The Illustrated Buyer's Guide to DeLorean Automobiles

**By James Espey
with foreword by William T. Collins, Jr.
Updated Second Edition**

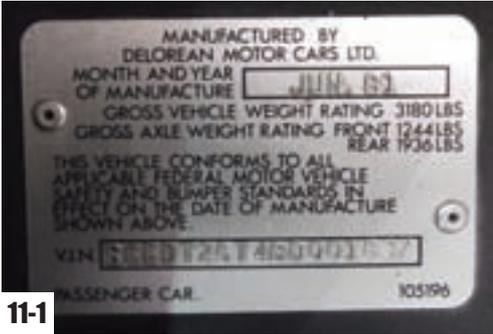
11-1

The complete Vehicle Identification Number (VIN) on a DeLorean is typically located in two places - the pop-rievted plate (11-1) in the driver's side door jamb about knee level, and the pop-rievted or glued plate on the dashboard (11-2).

The former almost always lists the “build month/year”, though in the case of the “1983” model DeLorean cars with VINs that end in 15XXX, 16XXX and 17XXX, this build month/year is not accurate (*see page 116*). Some early cars in the 500 VIN-range don't have this plate at all. The build month/year may be stamped or embossed, with stamped dates more characteristic of early build cars. There is at least one known car where this area is blank, having never been stamped or embossed.

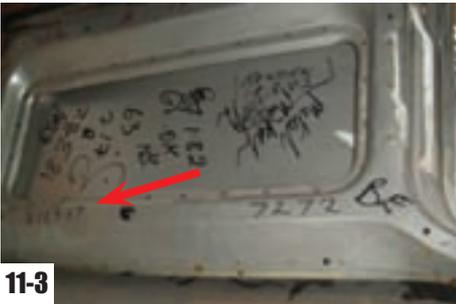
11-3

There are a couple other locations where you are likely to find at least the last five digits of the VIN, and those are on the stainless under the door headliners (11-3) typically on later, single-key cars and on the rear cross member of the frame (11-4), behind the impact absorber.

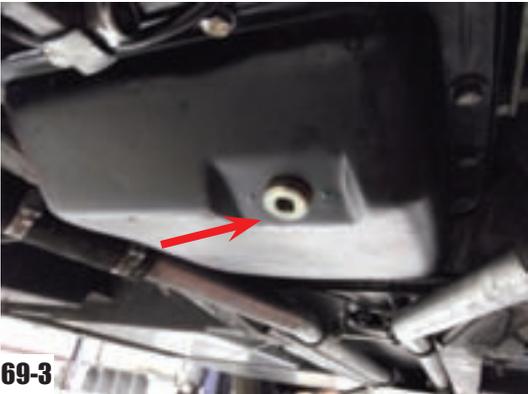
69-3

Transmission Pan Drain Plug (Automatic): Similar to the oil pan drain plug, the same tool can be used to remove this plug (69-3). The same seal washer should be used here, as well.

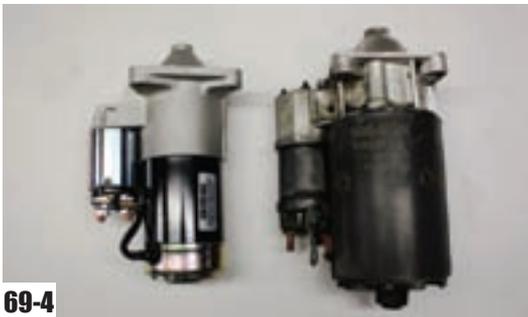
69-4

Starter: The factory Paris-Rhone starter (69-4, right) has proven to be very reliable, but in recent years the correct internal parts required for rebuilds have been discontinued. Original starters are no longer available, but solenoids can typically be had at a price when needed. In most cases, an upgrade to the smaller, quieter and more modern starter (69-4, left) offered by the full-service vendors is a better choice.

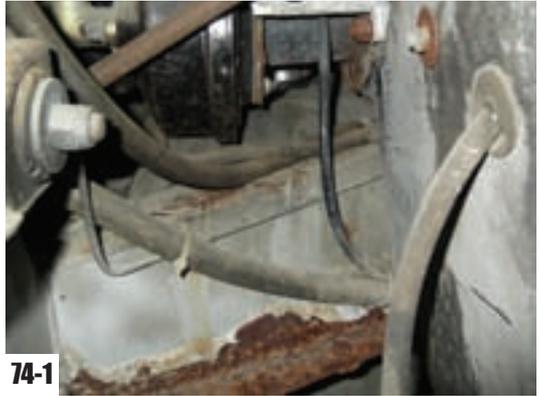
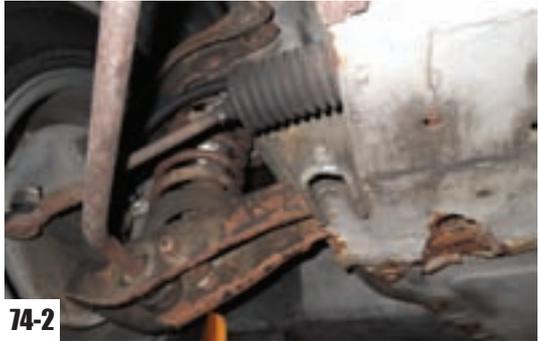
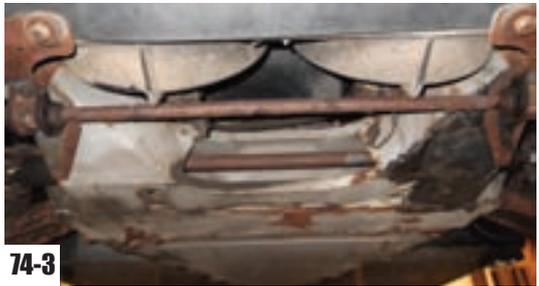
Fiberglass Underbody: It doesn't necessarily take a severe accident to have damage to the fiberglass underbody. Many times, it goes unnoticed or is sloppily repaired as it's "out of sight". Look for cracks in the visible portions, particularly in the area at the corners of the radiator and also the front and rear wheel wells. Unusual looking patches were sometimes performed at the factory to correct imperfections in otherwise good underbodies. If in doubt, get a qualified bodywork professional to examine and offer an expert opinion.

Frame and Roof Rust: While the stainless body, urethane bumpers and fiberglass underbody won't rust, an increasingly common problem with DeLorean cars is rust on the frame and in the roof box. Quite possibly the most expensive issue to be aware of when inspecting a DeLorean for purchase, the impact of rust on the frame, suspension components and/or roof box cannot be overstated.

The mild steel frames were coated with a two-part epoxy with the idea that this would provide corrosion protection. In many cases, this is true, but particularly in areas where salt is used on roads, or salt air is prevalent, close attention should be noted to the condition of the frame and suspension components. The epoxy will crack with age rather than flex, and allow moisture to become trapped between the steel frame and epoxy, accelerating corrosion.

The need for careful examination cannot be overstressed (74-1 and 74-2) as the epoxy may look good, but in reality can be nothing more than a shell over

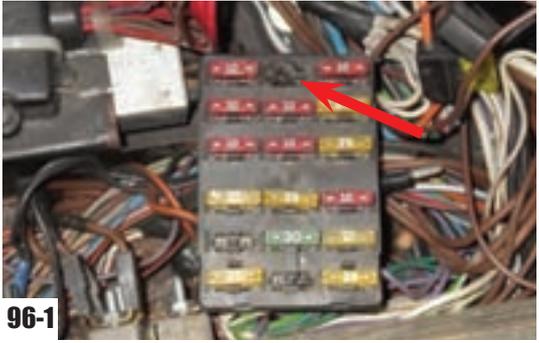
96-1

Electrical Relays/Fuses: An examination of the fusebox and relay compartment is advised. It is not uncommon that at least one of the fuses and/or fuse receptacles will be melted (96-1). This is usually the result of corrosion on the fuses and heat buildup. The installation of inline fuses is one option, though an improved reproduction fuse box is also available. The electrical relays and circuit breakers also merit attention. The original fan fail relay and cabin fan circuit breakers are prone to failure and some of the others are underrated or of poor quality. Relay update kits, which replace these components, are recommended for all cars that have not had these previously replaced.

Typically, if a car still has the blue fan fail relay installed, or an *unfused* wire jumper in that location, the odds are very good that it still has the original relays and should be updated.
