The Illustrated Buyer's Guide to DeLorean Automobiles

**By James Espey
with foreword by William T. Collins, Jr.
Updated Second Edition**

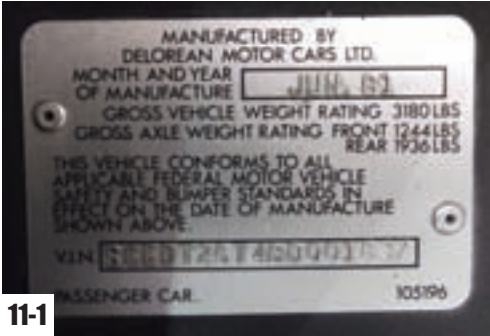
11-1

The complete Vehicle Identification Number (VIN) on a DeLorean is typically located in two places - the pop-rievted plate (11-1) in the driver's side door jamb about knee level, and the pop-rievted or glued plate on the dashboard (11-2).

The former almost always lists the “build month/year”, though in the case of the “1983” model DeLorean cars with VINs that end in 15XXX, 16XXX and 17XXX, this build month/year is not accurate (*see page 116*). Some early cars in the 500 VIN-range don't have this plate at all. The build month/year may be stamped or embossed, with stamped dates more characteristic of early build cars. There is at least one known car where this area is blank, having never been stamped or embossed.

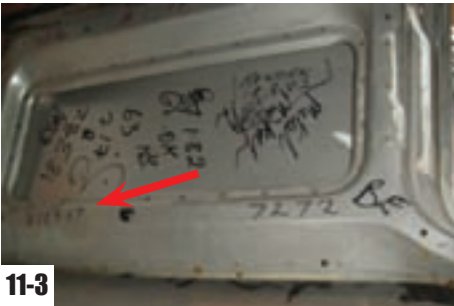
11-3

There are a couple other locations where you are likely to find at least the last five digits of the VIN, and those are on the stainless under the door headliners (11-3) typically on later, single-key cars and on the rear cross member of the frame (11-4), behind the impact absorber.

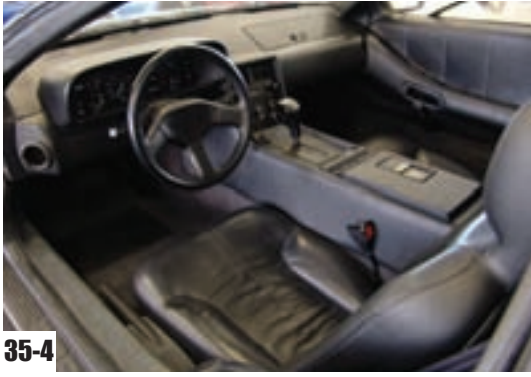
35-4

Carpets: Three different carpet colors and two different types of carpet were used during production. Black interior cars up to approximately VIN 10578 have a coarse dark grey/charcoal color carpet (*35-1 and 35-4*). Grey interior cars up to approximately VIN 10578 have a coarse light grey color carpet (*35-2 and 35-5*). Both grey *and* black interior cars from approximately VIN 10579 have a smooth textured light grey carpet (*35-3 and 35-6*).

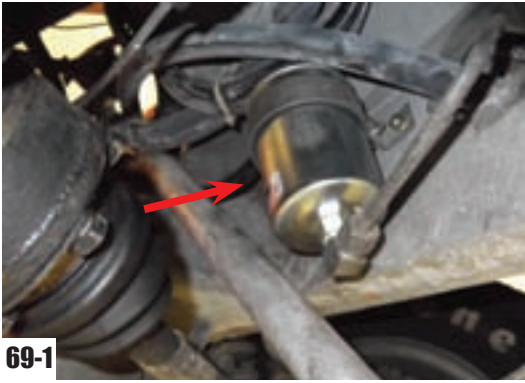
69-1

has a recessed 5/16" opening, and requires the same sized tool to remove. This tool is readily available from any full-service DeLorean vendor. Over the years, some owners have replaced this with a more conventional drain plug. A new seal washer - included with filters obtained from most of the full-service DeLorean vendors - should be replaced at every oil change.

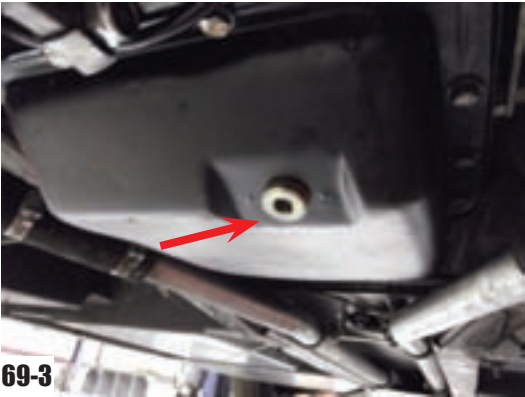
69-3

Transmission Pan Drain Plug (Automatic): Similar to the oil pan drain plug, the same tool can be used to remove this plug (69-3). The same seal washer should be used here, as well.

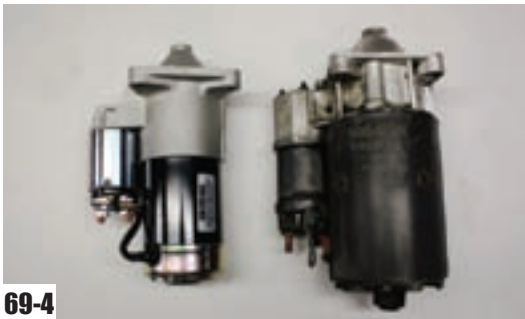
69-4

Starter: The factory Paris-Rhone starter (69-4, right) has proven to be very reliable, but in recent years the correct internal parts required for rebuilds have been discontinued. Original starters are no longer available, but solenoids can typically be had at a price when needed. In most cases, an upgrade to the smaller, quieter and more modern starter (69-4, left) offered by the full-service vendors is a better choice.

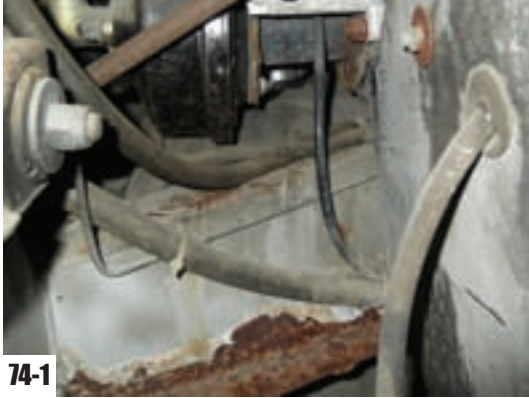
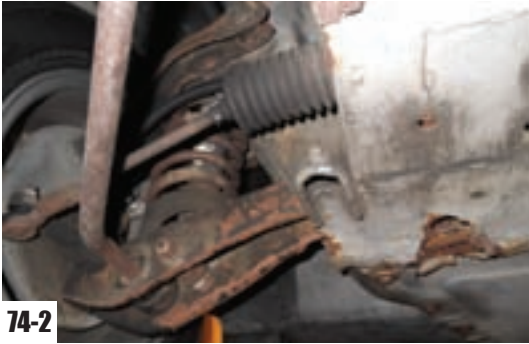
The need for careful examination cannot be overstressed (74-1 and 74-2) as the epoxy may look good, but in reality can be nothing more than a shell over

The mild steel frames were coated with a two-part epoxy with the idea that this would provide corrosion protection. In many cases, this is true, but particularly in areas where salt is used on roads, or salt air is prevalent, close attention should be noted to the condition of the frame and suspension components. The epoxy will crack with age rather than flex, and allow moisture to become trapped between the steel frame and epoxy, accelerating corrosion.

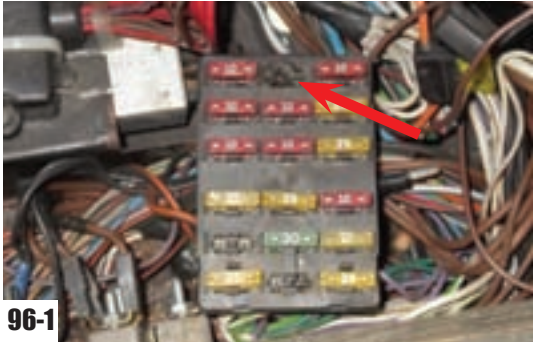
96-1

Electrical Relays/Fuses: An examination of the fusebox and relay compartment is advised. It is not uncommon that at least one of the fuses and/or fuse receptacles will be melted (96-1). This is usually the result of corrosion on the fuses and heat buildup. The installation of inline fuses is one option, though an improved reproduction fuse box is also available. The electrical relays and circuit breakers also merit attention. The original fan fail relay and cabin fan circuit breakers are prone to failure and some of the others are underrated or of poor quality. Relay update kits, which replace these components, are recommended for all cars that have not had these previously replaced.

Typically, if a car still has the blue fan fail relay installed, or an *unfused* wire jumper in that location, the odds are very good that it still has the original relays and should be updated.

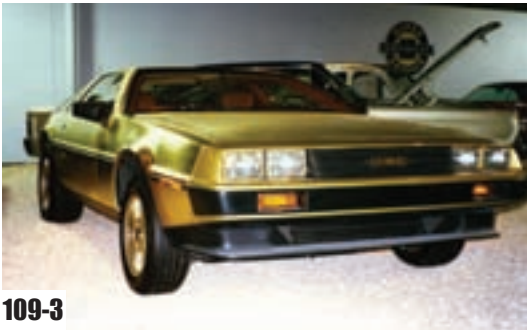
109-3

Gold Cars: The 1980 American Express Christmas catalog offered a limited edition of 100 24K gold-plated DeLorean cars at \$85,000 each. Only two were sold by American Express (VIN 4300 and 4301).

VIN 4300 has a tan interior and a manual transmission, while VIN 4301 has a black interior and a manual transmission. The only other example of a tan interior DeLorean is VIN 20105.
